**Re: Public Comments on FPA No. 2819391**

May 27, 2024

Re: **Comments on Forest Practice Application 2819391**  
Lake Cavanaugh, Skagit County, Washington

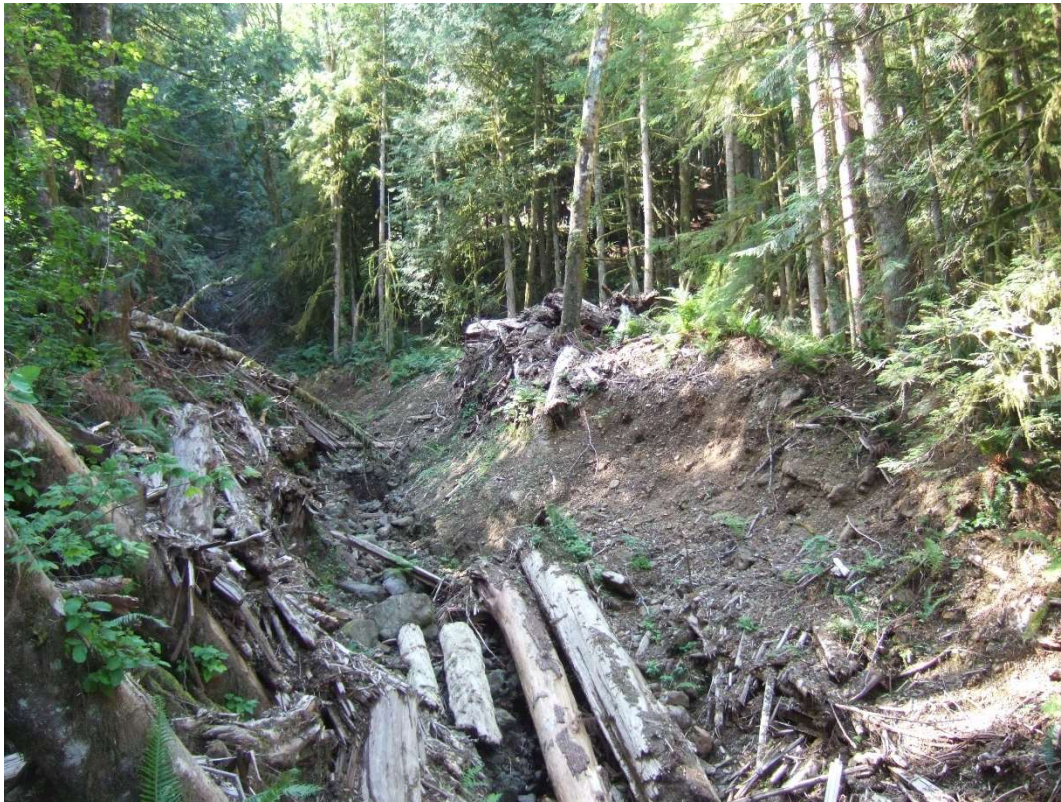
Large logs from debris flow in stream two watersheds to the west, a similar sizes and gradient stream to Stream #2. Note large logs deposited as much as 20 feet above bottom of stream channel.

*Id.* at 5. “Large debris flows with large logs will very likely become jammed at a bridge crossing at [the proposed bridge over Stream #2]. This will alter the flow path of the debris flows out of the channel increasing the risk to down slope properties that are located away from the stream path and also potentially causing a larger debris dam failure downstream of the bridge location.” *Id.* at 4. In sum, as stated by Mr. McShane:

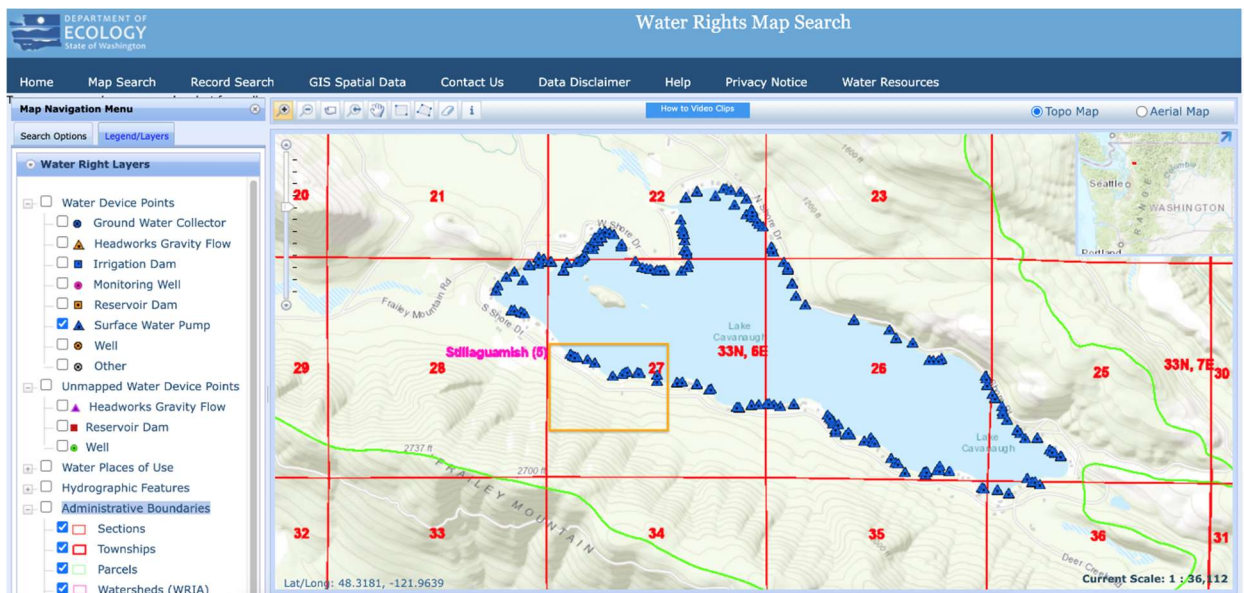
All of the project streams drain to Lake Cavanaugh, which supplies drinking water via surface water withdrawals for dozens of residences. The figure below includes only surface water pump devices around the lake (excluding wells). The area of the proposed land disturbing activity is highlighted with an orange box:

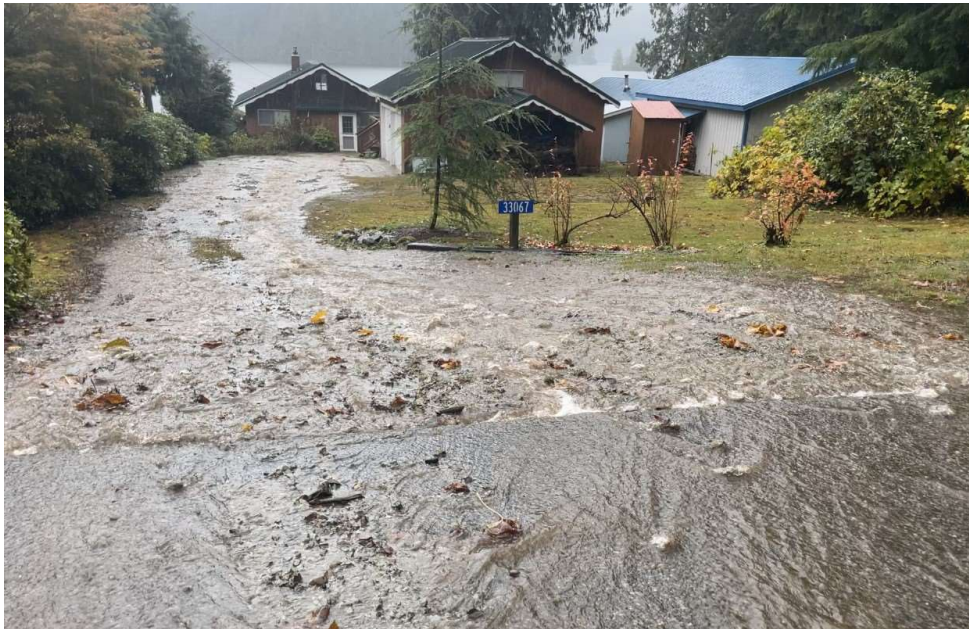
In its SEPA Checklist, the applicant admits that "fuel, oils or other heavy machinery waste materials may inadvertently reach surface waters because of heavy equipment use or failures." SEPA Checklist Question B.3.a.6 (PDF 6). Moreover, the applicant admits that "sediment from road building and logging could enter surface waters." SEPA Checklist Question B.3.c.2 (PDF 7). That is an understatement. The photograph below shows increased runoff about to enter the lake (in the background), laden with sediment, from last year's logging that was performed in the immediate area of this proposal, where residential lots were impacted and increased runoff flooded South Shore Drive:

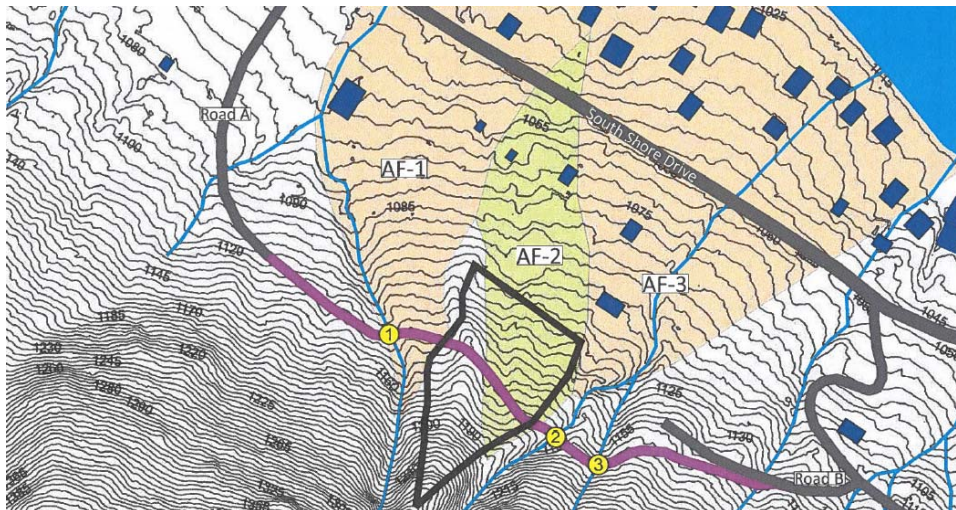
Figure 12 from Icicle report

The geotechnical report (Icicle Creek Engineers, 2023) identifies three alluvial fan areas: AF-1, AF-2 and AF-3. The report indicates that AF-1 and AF-3 are active alluvial fan areas. I concur with that assessment based on my on the ground observations of both AF-1 and AF-3 and my interpretation of the geology of the area and lidar bare earth imagery of the fans.

AF-2 is essentially part of the same alluvial fan as AF-3. Icicle has interpreted AF-2 as a relict alluvial fan on page 9 of their report:

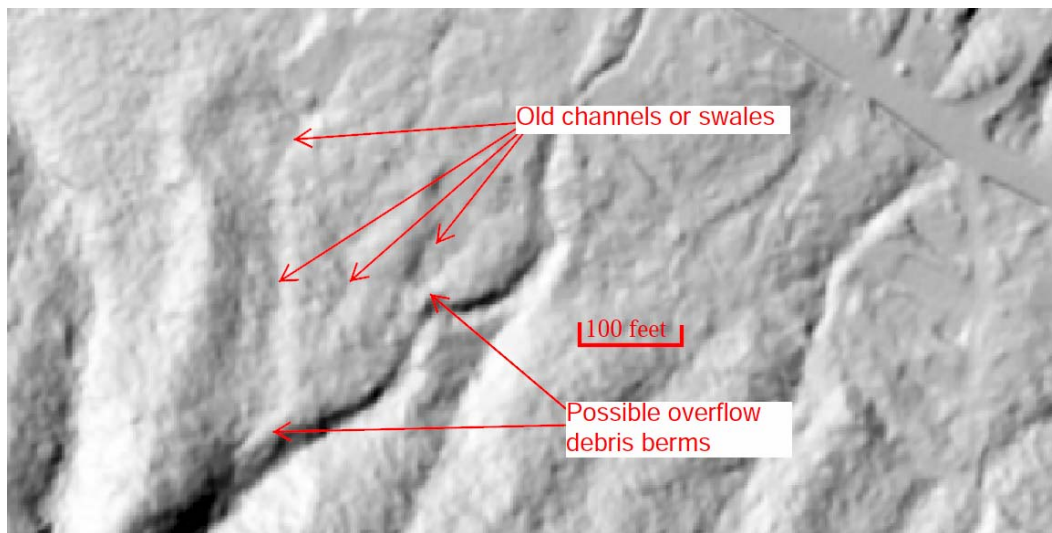
Lidar bare earth imagery of AF-2 and Stream 2

1. Lidar bare earth imagery shows that the surface of AF-2 shows what appear to be three swales or old channels on the fan area surface. These swales are not described in the report and suggest that stream channels occupied this surface in the past. The lidar also indicates features that appear to be overflow berms – a typical feature of debris flow deposition on alluvial fans.

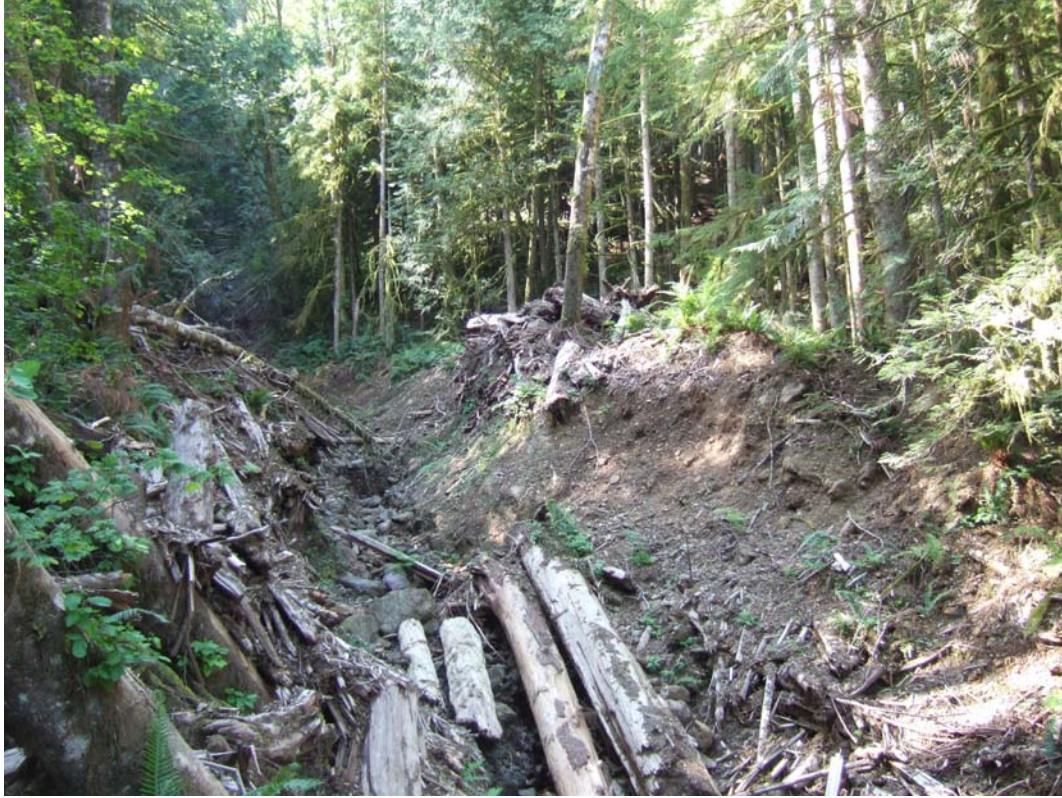
Large logs will likely be incorporated within the debris flows. Such has been the case on most of the debris flows on the streams coming off the upper ridge of Frailey Mountain (personal observations at six similar streams on the north side of Frailey Mountain and pictured below).

Large debris flows with large logs will very likely become jammed at a bridge crossing at this location. This will alter the flow path of the debris flows out of the channel increasing the risk to down slope properties that are located away from the stream path and also potentially causing a larger debris dam failure downstream of the bridge location.

Large logs from debris flow in stream two watersheds to the west, a similar sizes and gradient stream to Stream #2. Note large logs deposited as much as 20 feet above bottom of stream channel.
