**Forest Practices Application/Notification
Office Checklist Page 1
Northwest Region**

**Forest Practices Application/Notification
Western Washington**

Project Name: Cavanaugh A

This revised report presents the results of Icicle Creek Engineers' (ICE's) geological engineering services for an evaluation of Potentially Unstable Slopes and Landforms associated with the Cavanaugh Proposed Harvest Unit (PHU) owned by Nielsen Brothers Inc. The Cavanaugh PHU is located in Section 27, Township 33 North, Range 6 East, Willamette Meridian, along the south shore of Lake Cavanaugh in Skagit County, Washington. The location of the Cavanaugh PHU relative to nearby physical features is shown on the Vicinity Map, Figure 1. This revised report is intended to replace our original report dated June 10, 2019.

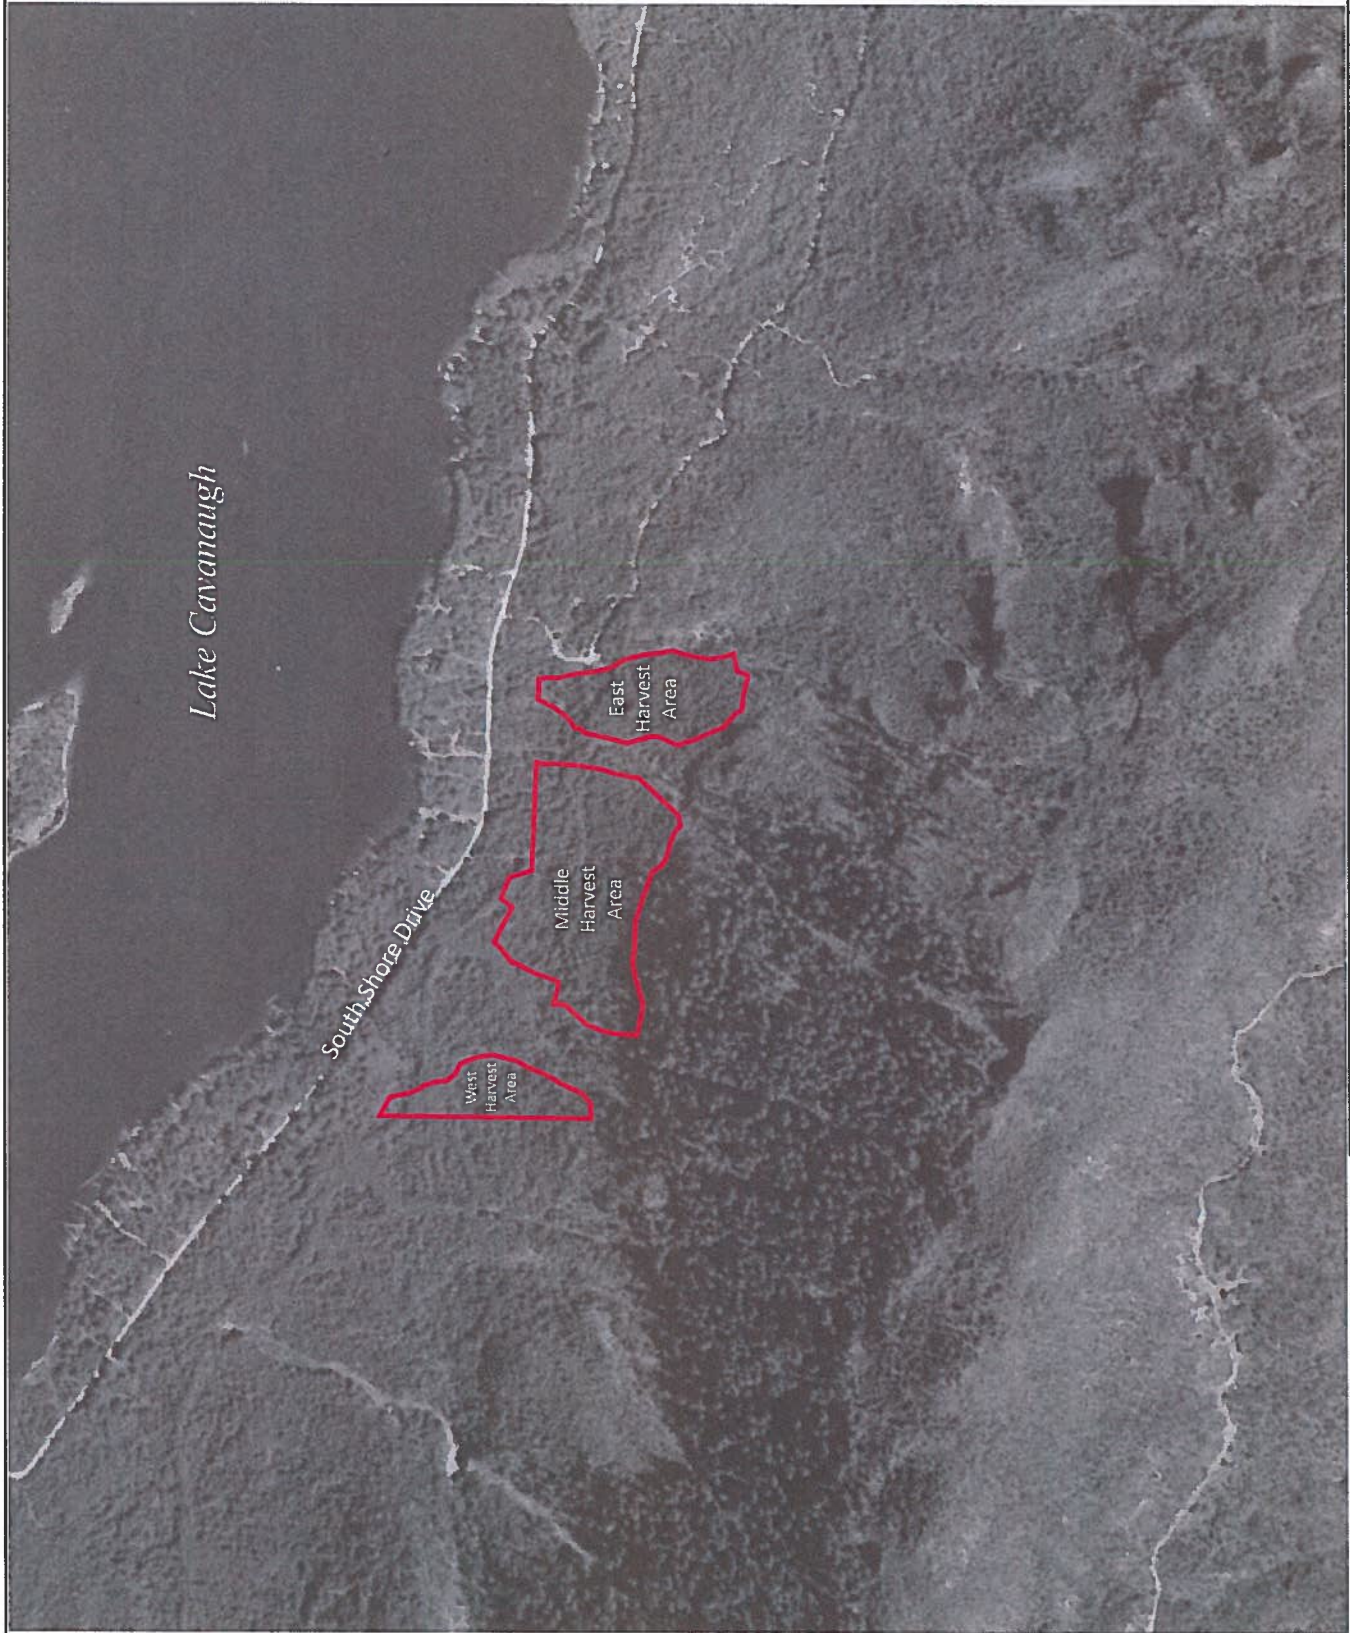
ICE FILE NO.
1319-001
Figure
8

Aerial photograph obtained from USGS EarthExplorer
(<https://earthexplorer.usgs.gov/>)

ICE reviewed historical aerial photographs of the Cavanaugh PHU area from 1941, 1953, 1974 (USGS EarthExplorer), 2006 and 2018 (Google Earth), as shown in Figures 7 through 11. The following is a summary of surface conditions observed on the aerial photographs.

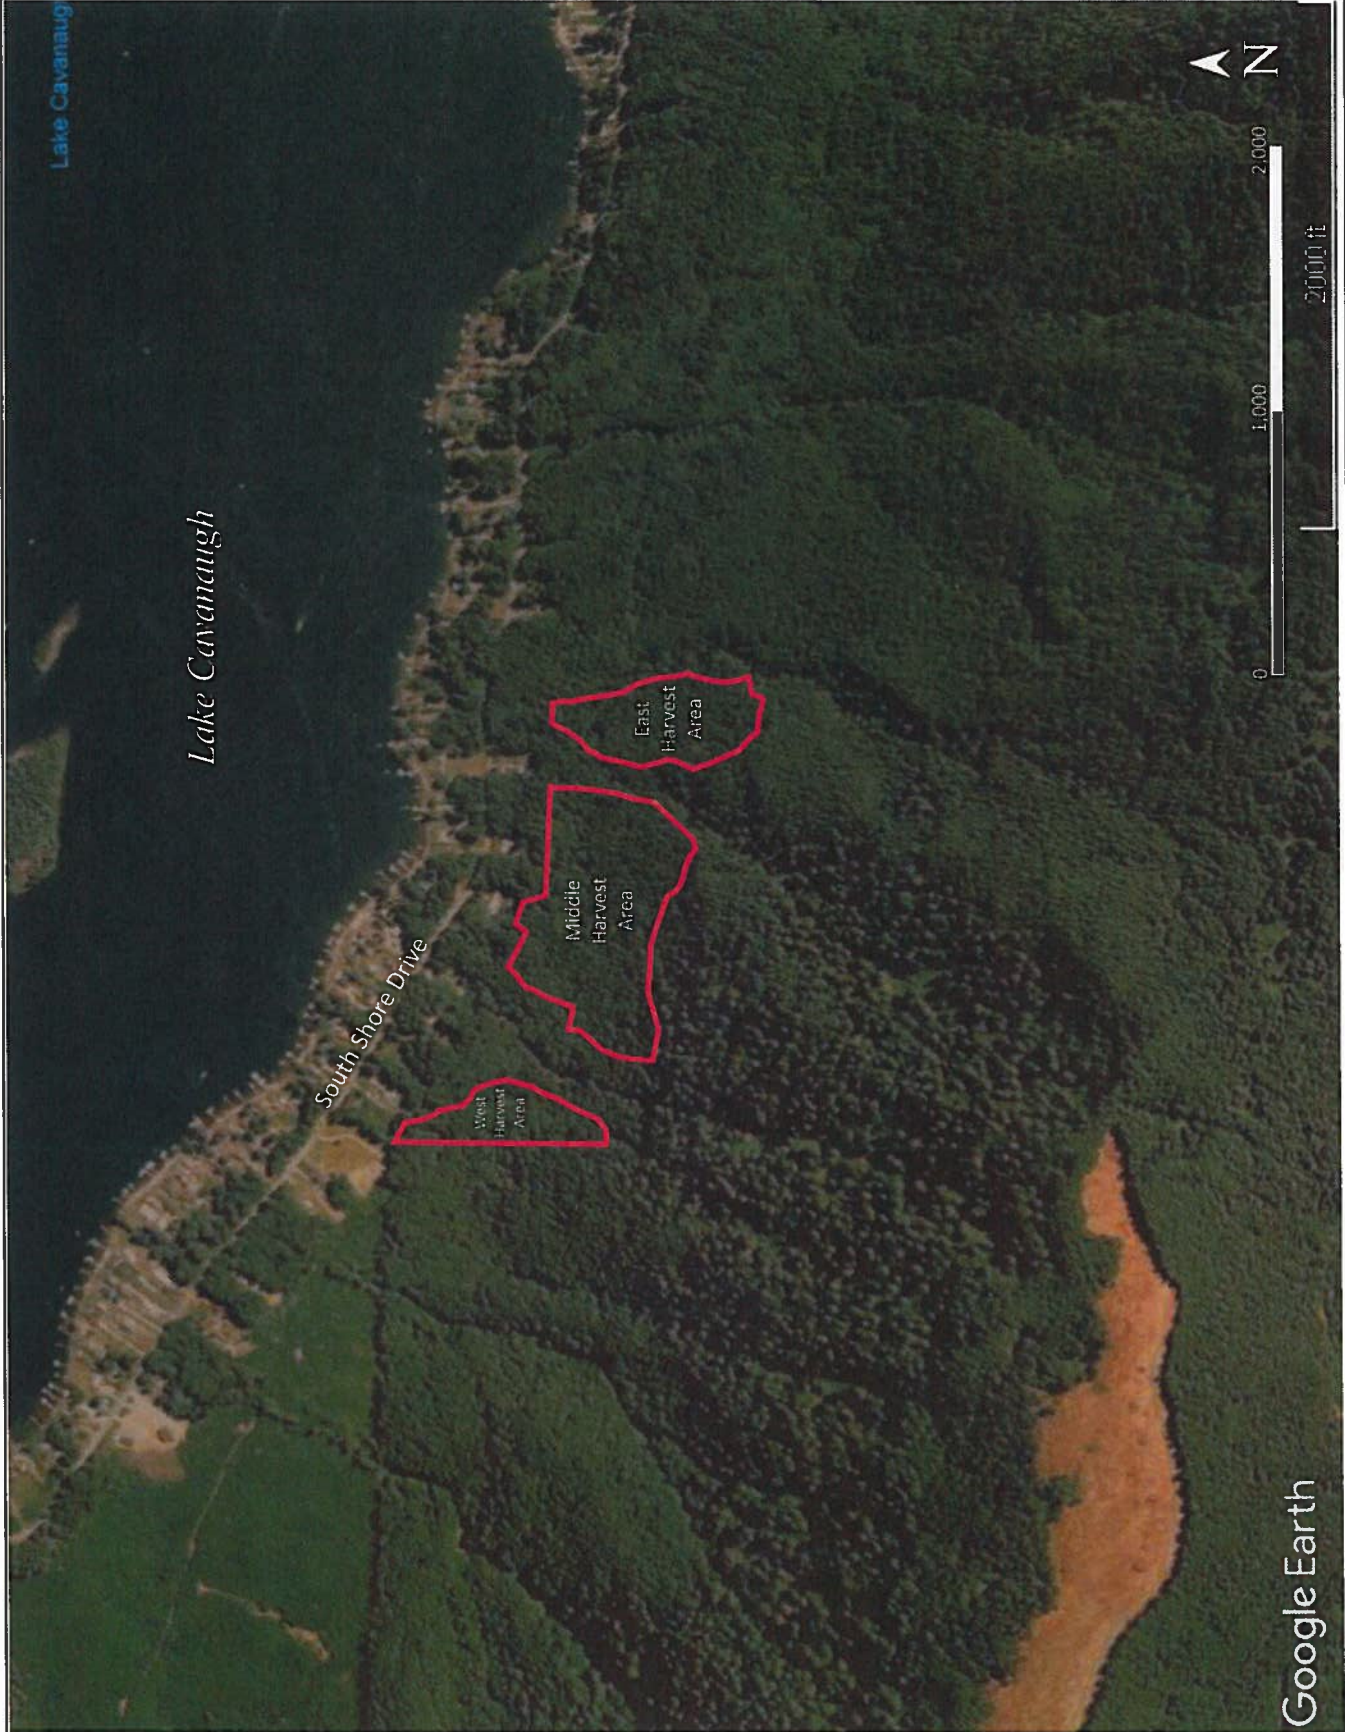
2006 AERIAL PHOTOGRAPH
CAVANAUGH PROPOSED HARVEST UNIT

Aerial photograph obtained from Google Earth
