POLLUTION CONTROL HEARINGS BOARD  
STATE OF WASHINGTON

LAKE CAVANAUGH TRUST,

DECLARATION OF WYATT  
GOLDING

**Wyatt Golding Declaration**  
**EXHIBIT A**

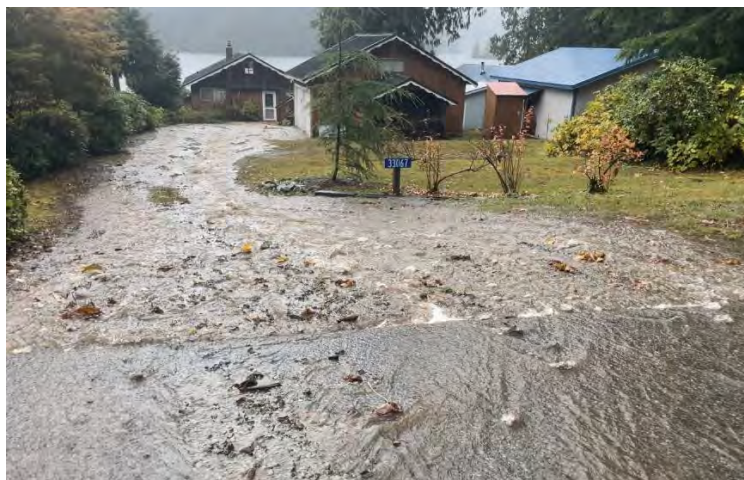
In its SEPA Checklist, the applicant admits that “fuel, oils or other heavy machinery waste materials may inadvertently reach surface waters because of heavy equipment use or failures.” SEPA Checklist Question B.3.a.6 (PDF 6). More generally and not limited to inadvertent failures, the applicant admits that “sediment from road building and logging could enter surface waters.” SEPA Checklist Question B.3.c.2 (PDF 7). That is an understatement. The photograph below shows increased runoff about to enter the lake (in the background), laden with sediment, from last year’s logging that was performed in the immediate area of this proposal. Those residential lots were directly and severely impacted from the increased runoff flooded that flooded those lots and South Shore Drive:

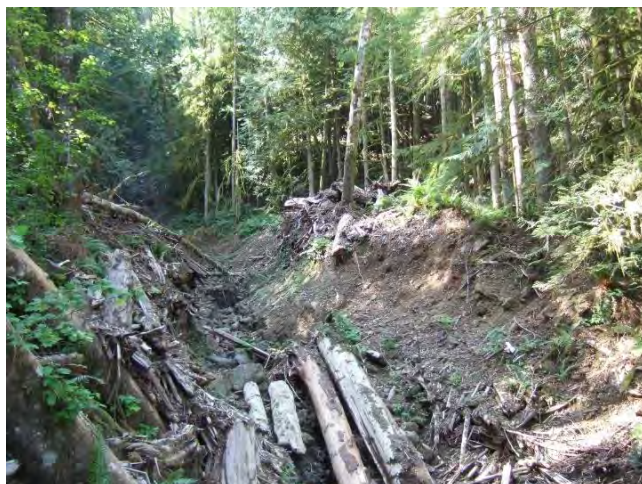
Large logs from debris flow in stream two watersheds to the west, a similar sizes and gradient stream to Stream #2. Note large logs deposited as much as 20 feet above bottom of stream channel.

*Id.* at 5. “Large debris flows with large logs will very likely become jammed at a bridge crossing at [the proposed bridge over Stream #2]. This will alter the flow path of the debris flows out of the channel increasing the risk to down slope properties that are located away from the stream path and also potentially causing a larger debris dam failure downstream of the bridge location.” *Id.* at 4. In sum, as stated by Mr. McShane:

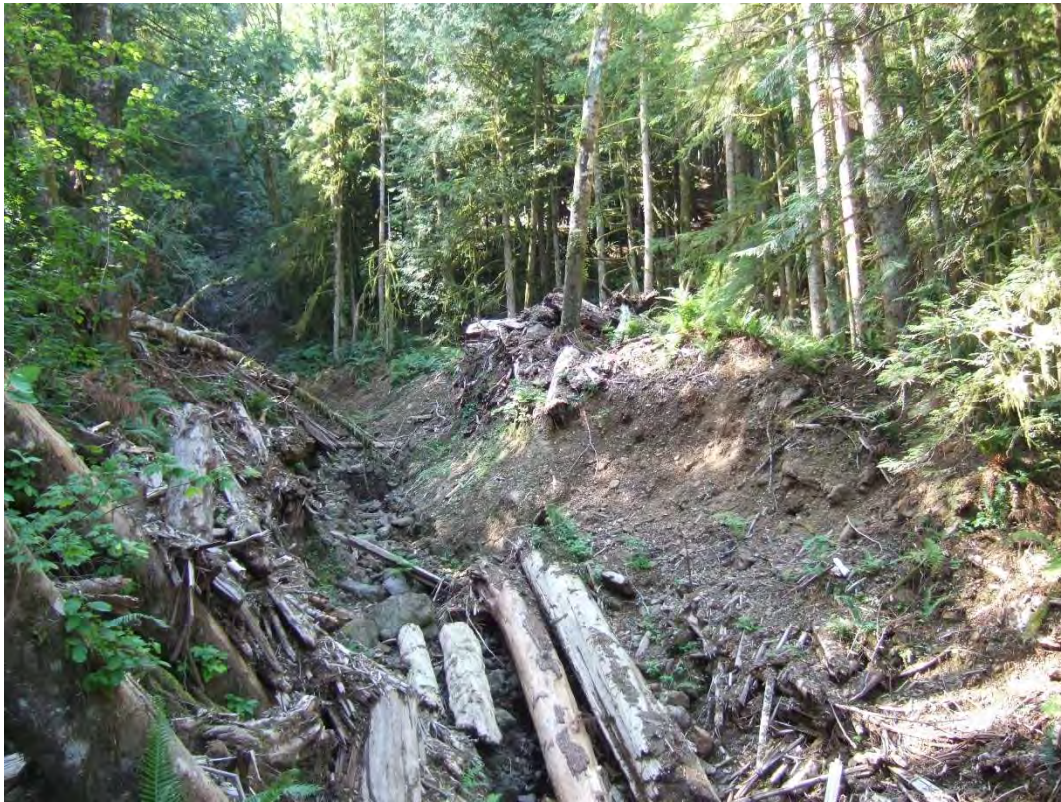
Large logs from debris flow in stream two watersheds to the west, a similar sizes and gradient stream to Stream #2. Note large logs deposited as much as 20 feet above bottom of stream channel.

*Id.* at 5. “Large debris flows with large logs will very likely become jammed at a bridge crossing at [the proposed bridge over Stream #2]. This will alter the flow path of the debris flows out of the channel increasing the risk to down slope properties that are located away from the stream path and also potentially causing a larger debris dam failure downstream of the bridge location.” *Id.* at 4. In sum, as stated by Mr. McShane:

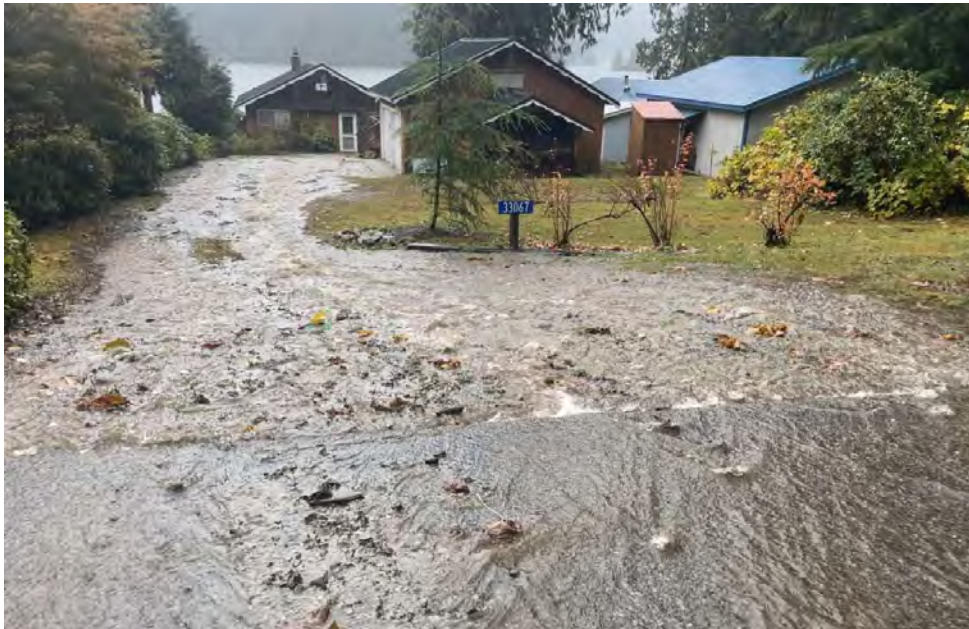
In its SEPA Checklist, the applicant admits that "fuel, oils or other heavy machinery waste materials may inadvertently reach surface waters because of heavy equipment use or failures." SEPA Checklist Question B.3.a.6 (PDF 6). Moreover, the applicant admits that "sediment from road building and logging could enter surface waters." SEPA Checklist Question B.3.c.2 (PDF 7). That is an understatement. The photograph below shows increased runoff about to enter the lake (in the background), laden with sediment, from last year's logging that was performed in the immediate area of this proposal, where residential lots were impacted and increased runoff flooded South Shore Drive:

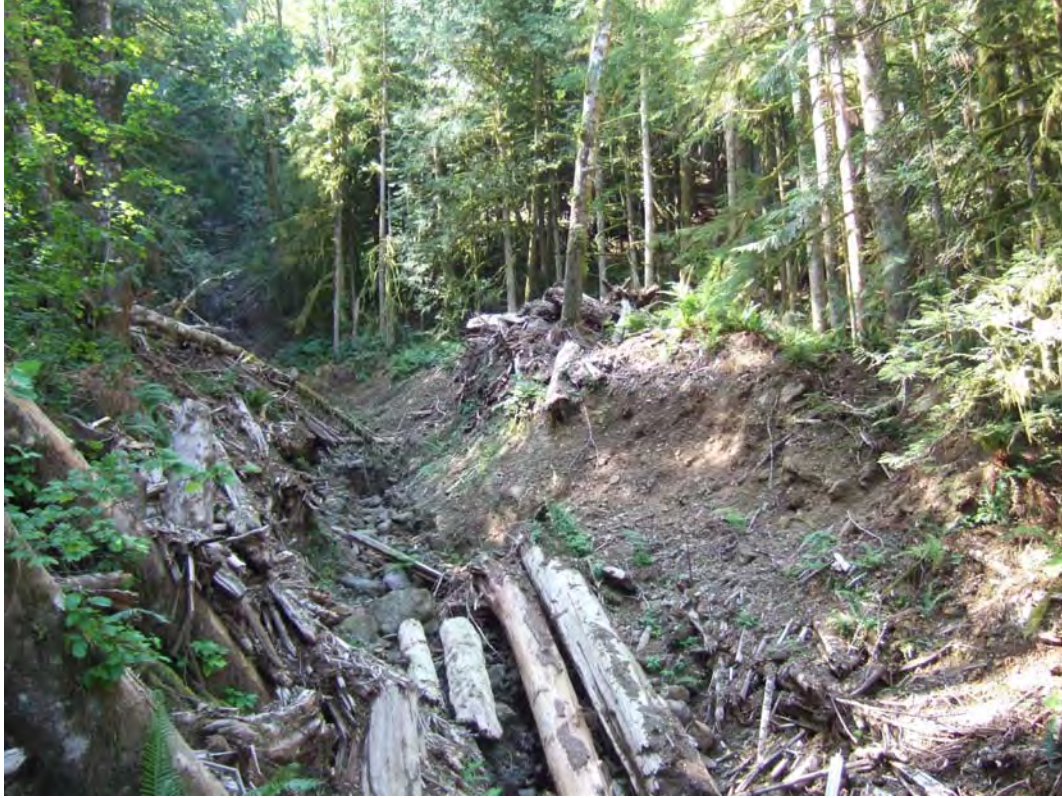
Large logs from debris flow in stream two watersheds to the west, a similar sizes and gradient stream to Stream #2. Note large logs deposited as much as 20 feet above bottom of stream channel.

Large debris flows with large logs will very likely become jammed at a bridge crossing at this location. This will alter the flow path of the debris flows out of the channel increasing the risk to down slope properties that are located away from the stream path and also potentially causing a larger debris dam failure downstream of the bridge location.

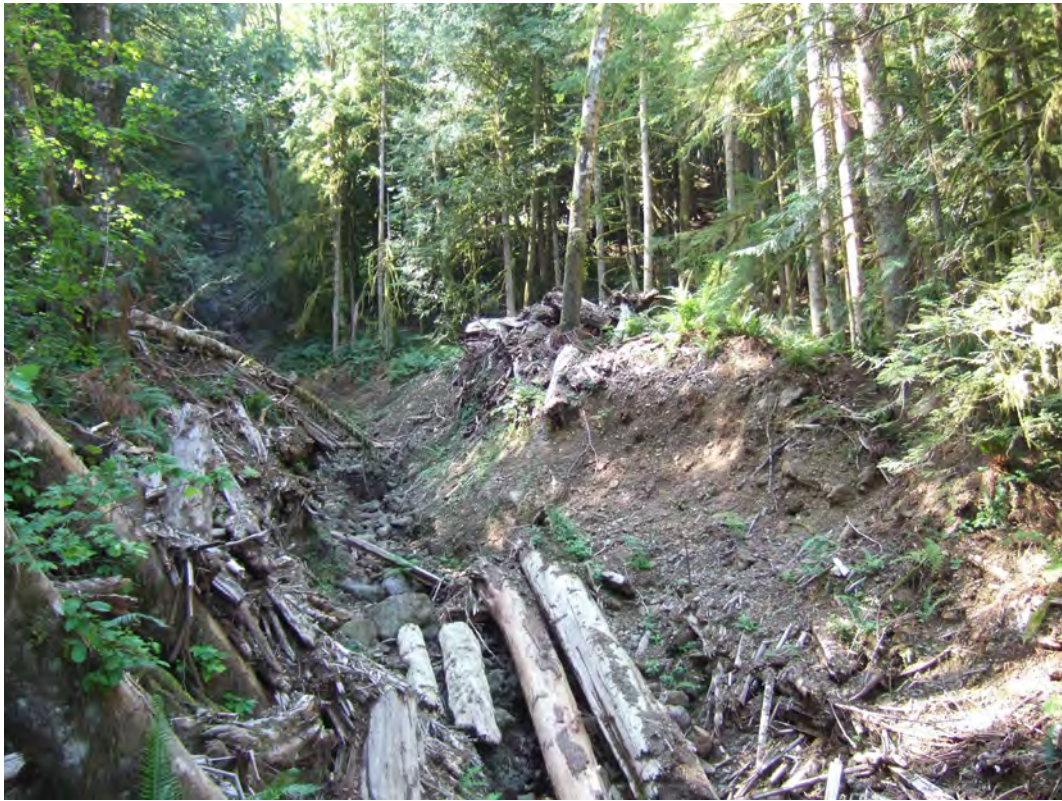
Large logs from debris flow in stream two watersheds to the west, a similar sizes and gradient stream to Stream #2. Note large logs deposited as much as 20 feet above bottom of stream channel.

Large debris flows with large logs will very likely become jammed at a bridge crossing at this location. This will alter the flow path of the debris flows out of the channel increasing the risk to down slope properties that are located away from the stream path and also potentially causing a larger debris dam failure downstream of the bridge location.
