## Forest Practices Application/Notification Western Washington

Project Name: Cavanaugh Road A Extension

WA DNR FPA Map - FPA #  
 Township 33N Range 06E Section 27 - Parcel# P67021 Skagit County  
 Timberline Logging LLC  
 Elevation: 1200'  
 Road Construction: ~1325' -- Unit 1 Harvest Area: 1.4 acres

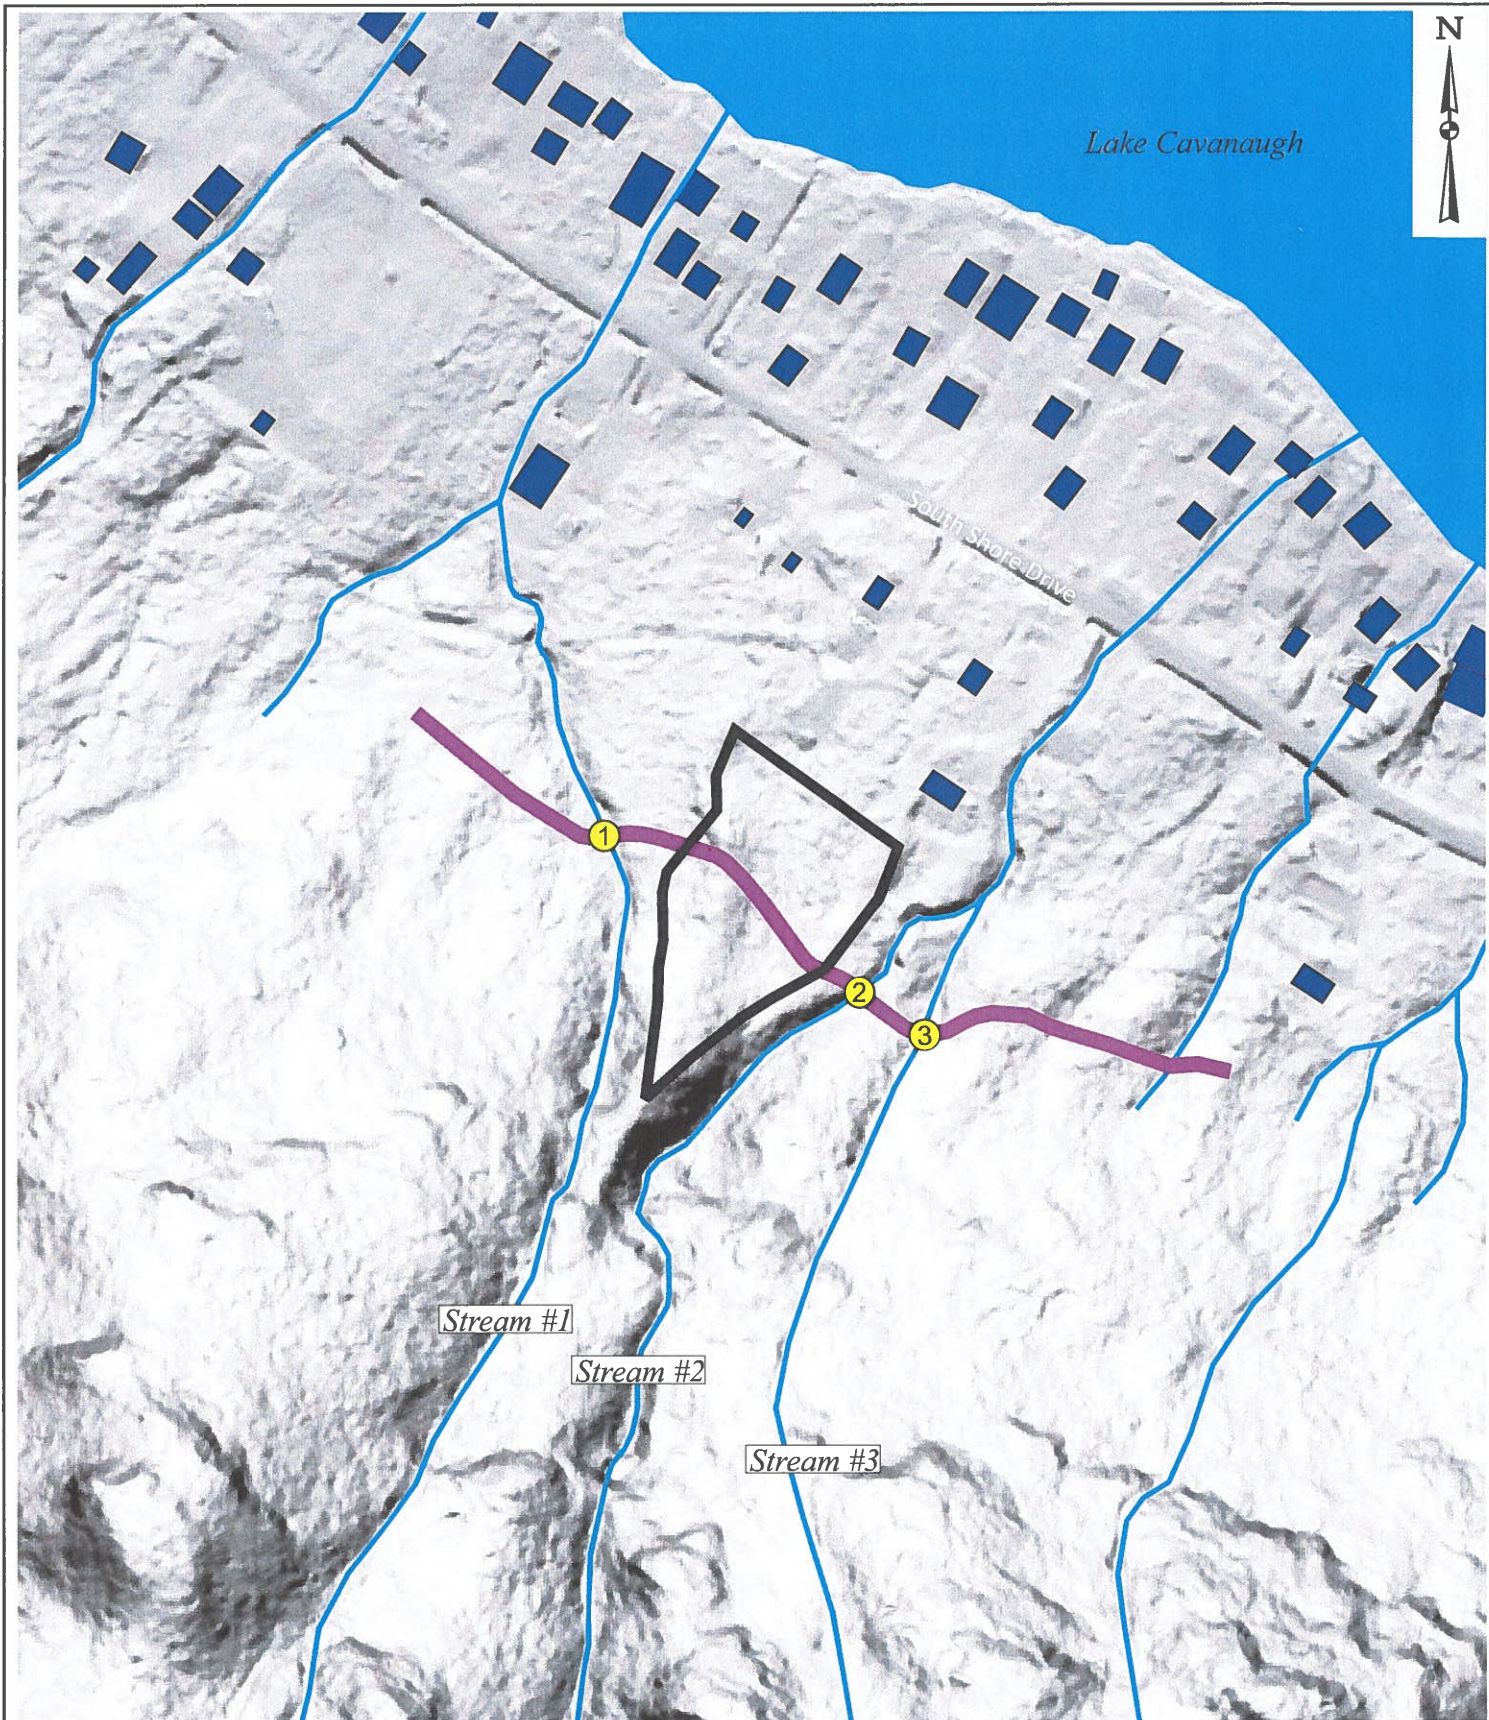
Digital Terrain Model (DTM) bare-earth hillshade image (North Puget 2017 acquisition) obtained from the Washington State Department of Natural Resources Washington LIDAR Portal (<http://lidarportal.dnr.wa.gov>).

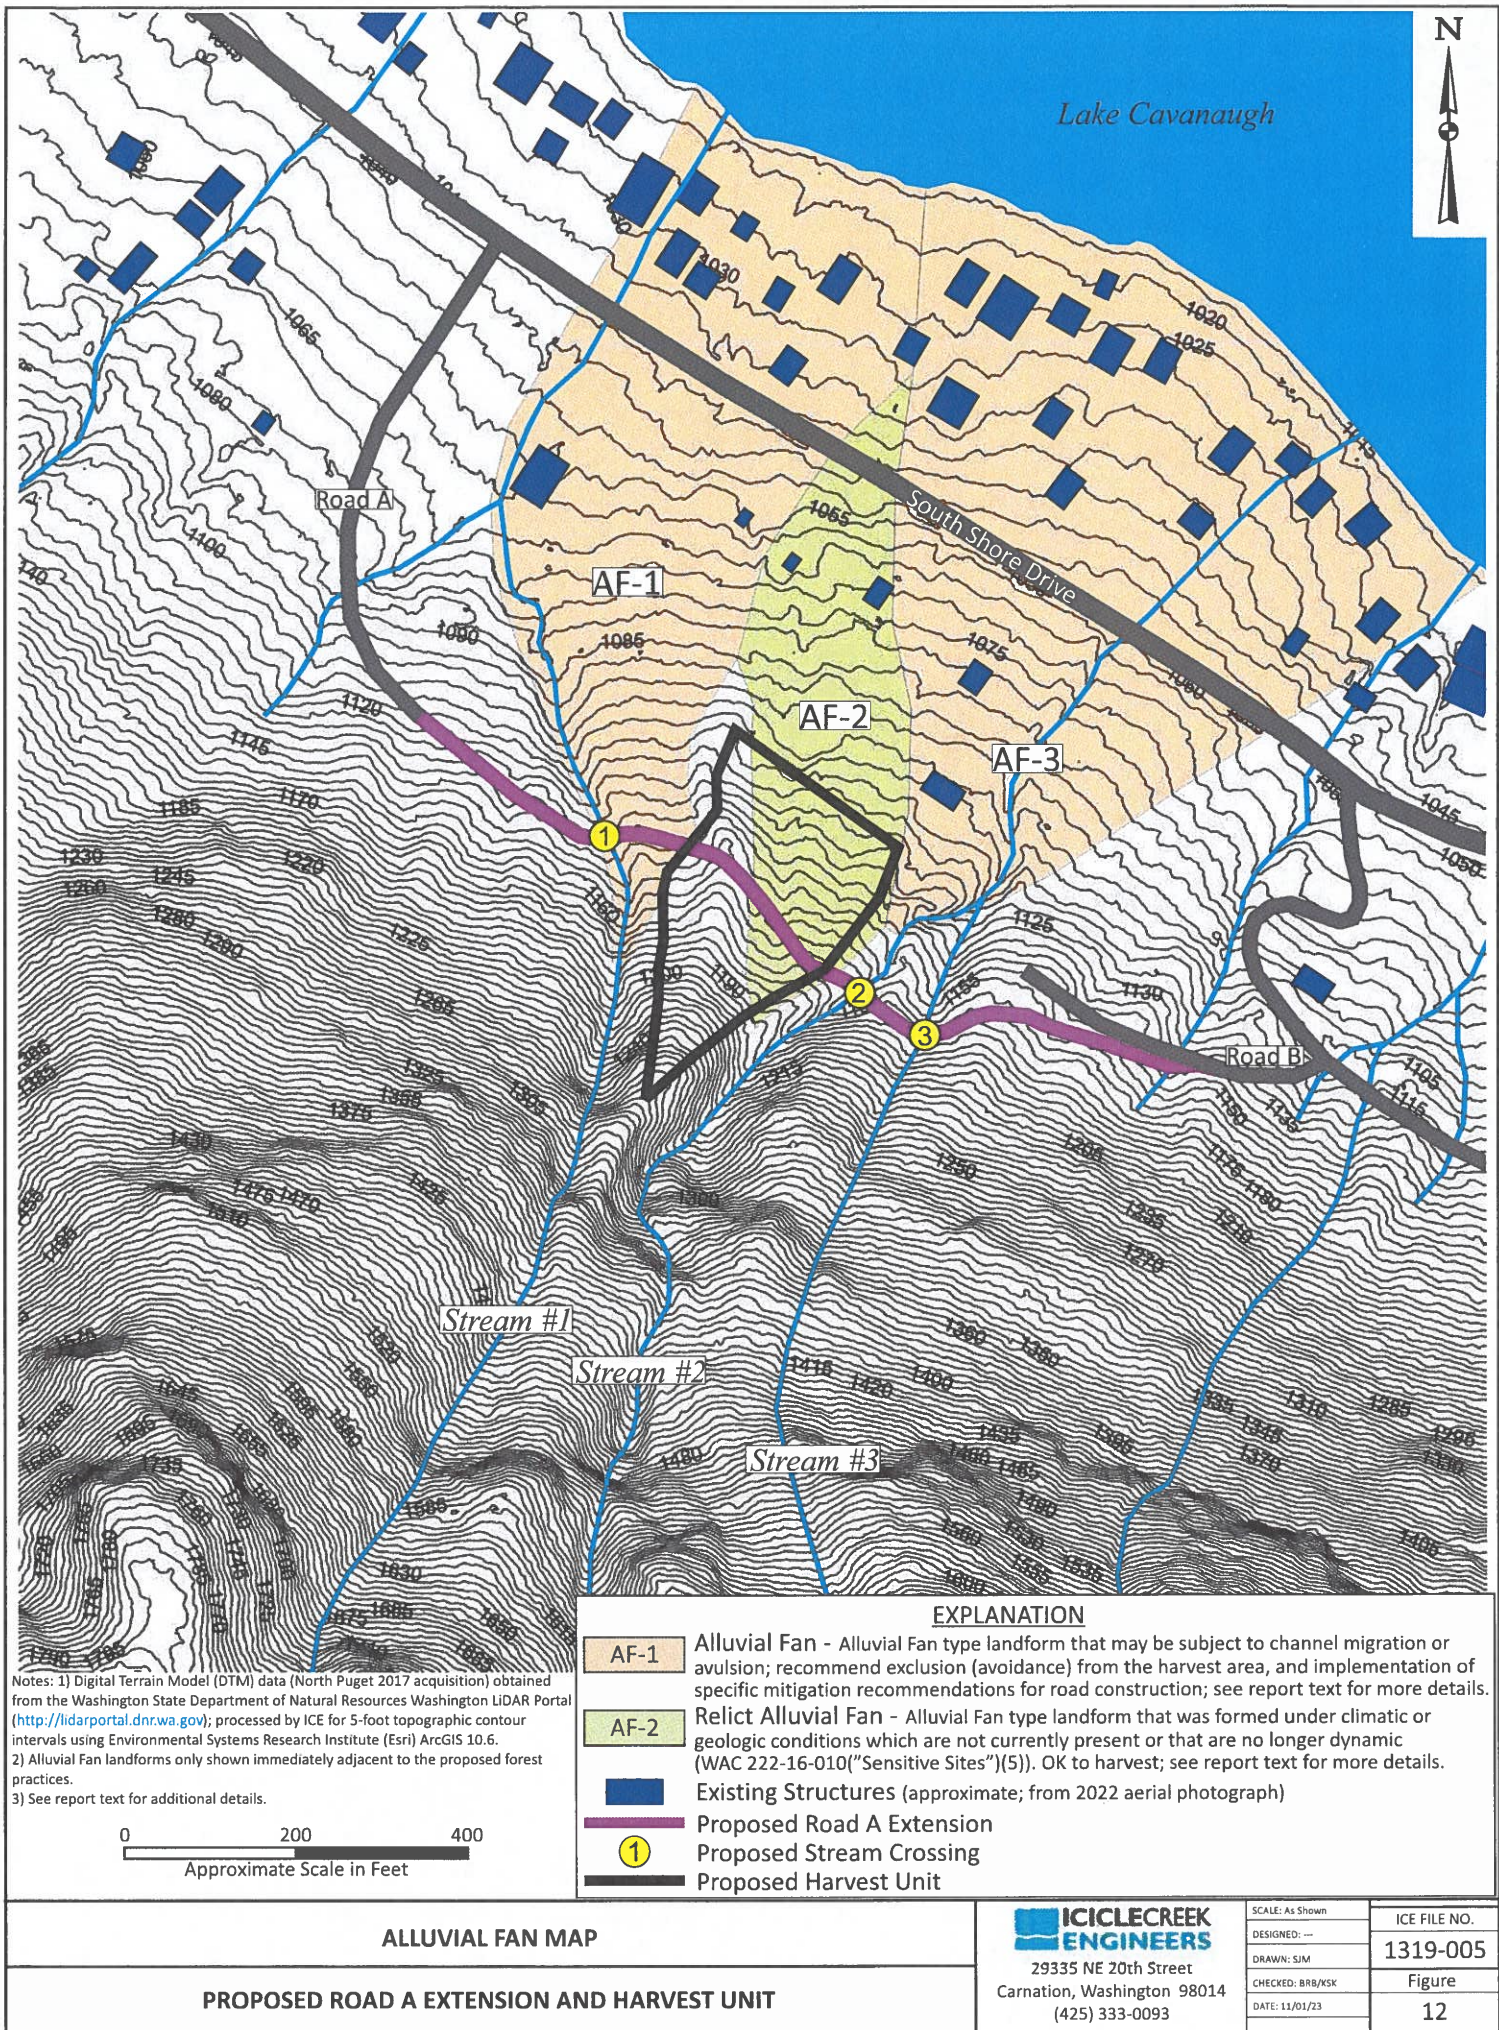
As previously described, we observed features consistent with Alluvial Fan landforms in the vicinity of the proposed forest practices during our initial review. These landforms are shown on the Alluvial Fan Map, Figure 12, as AF-1 through AF-3. Our site observations regarding each landform are described below.

We did not observe evidence of recent or historic channel avulsion, overtopping or accumulation on this surface. We did not observe evidence of streambank erosion or high water (such as scouring or sediment/woody debris deposition) at the apex, which could indicate a history of high flow events or debris flows with potential to inundate AF-3. In our opinion, AF-2 was formed when Stream #2 was at a higher base elevation, and therefore under geologic conditions which are not currently present and are no longer dynamic; based on our evaluation, AF-2 should be considered **Relict**, and is not considered an Alluvial Fan from a regulatory perspective (WAC 222-16-010("Sensitive Sites"))(5)).
